Foil C2115W1 Preliminary Examination

Laboratory for Space Sciences, Washington University, St. Louis, MO 63130, USA

Frank Stadermann, Christine Floss, Kuljeet Marhas, Ernst Zinner
June, 2006

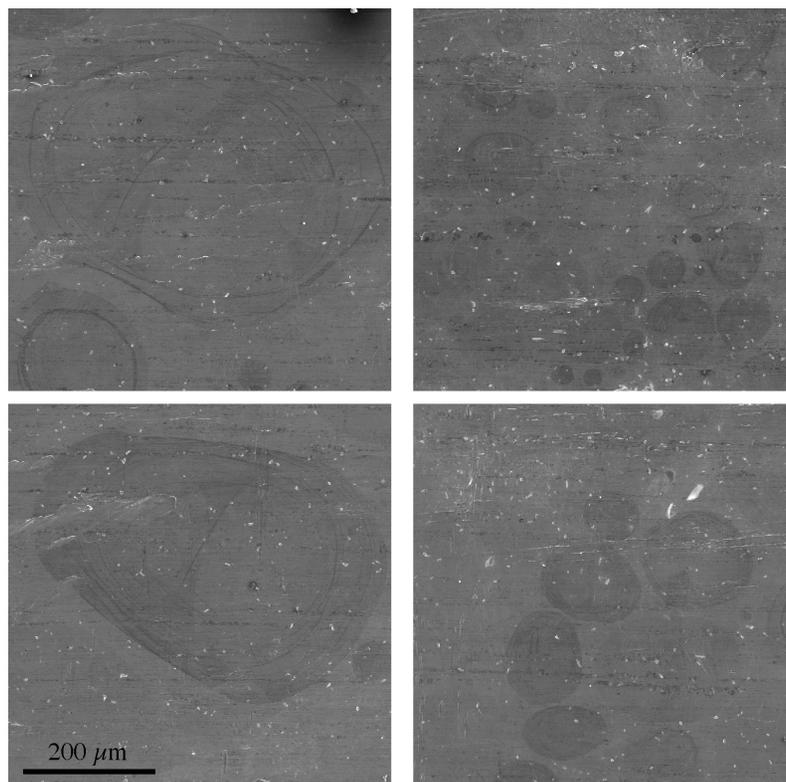
On this foil we found numerous dark circular patches that looked like dried droplets of some kind of liquid. These ranged in size from about 1 to 500 μm and their density is quite variable over the area of the foil; EDX analyses of these areas (at 10 kV) did not show the presence of any noticeable elements (other than Al). We suspect that they probably represent some type of pre- or post-mission contamination. We did not observe these circles on any of the other foils we received.
